Navajo Abandoned Uranium Mine

Site Screen Report

Mine Name: Montezuma No. 2
Mine IDs: 163, 165, 166

August 2011

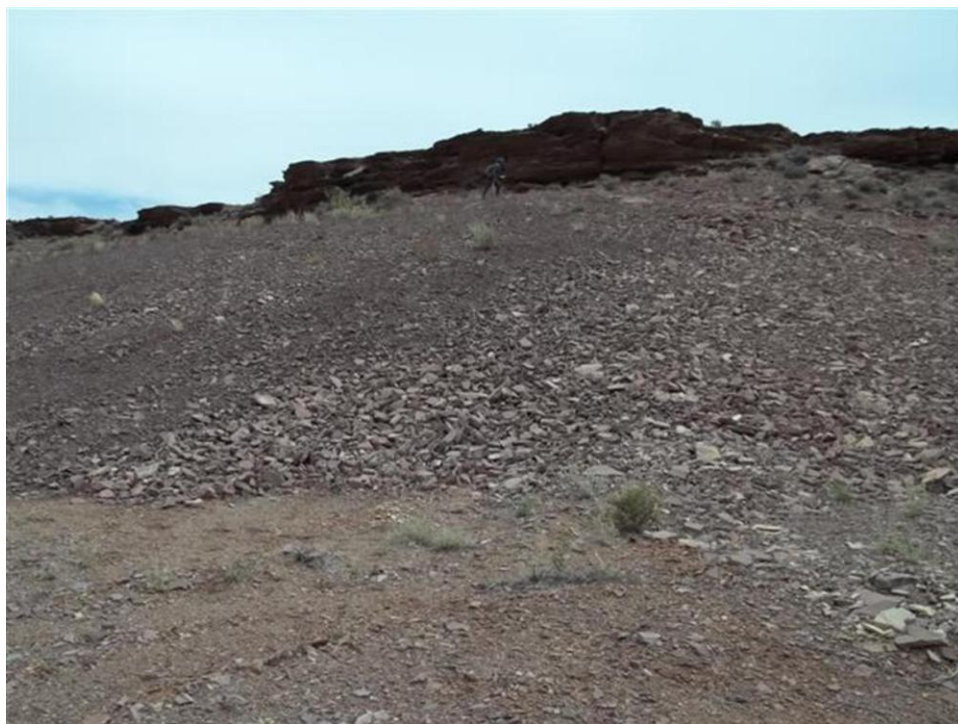
Reclamation cap, 100' x 150' x 5', rocky red-brown rocks, down slope

Photo 2: Mine Site #163; Reclamation area

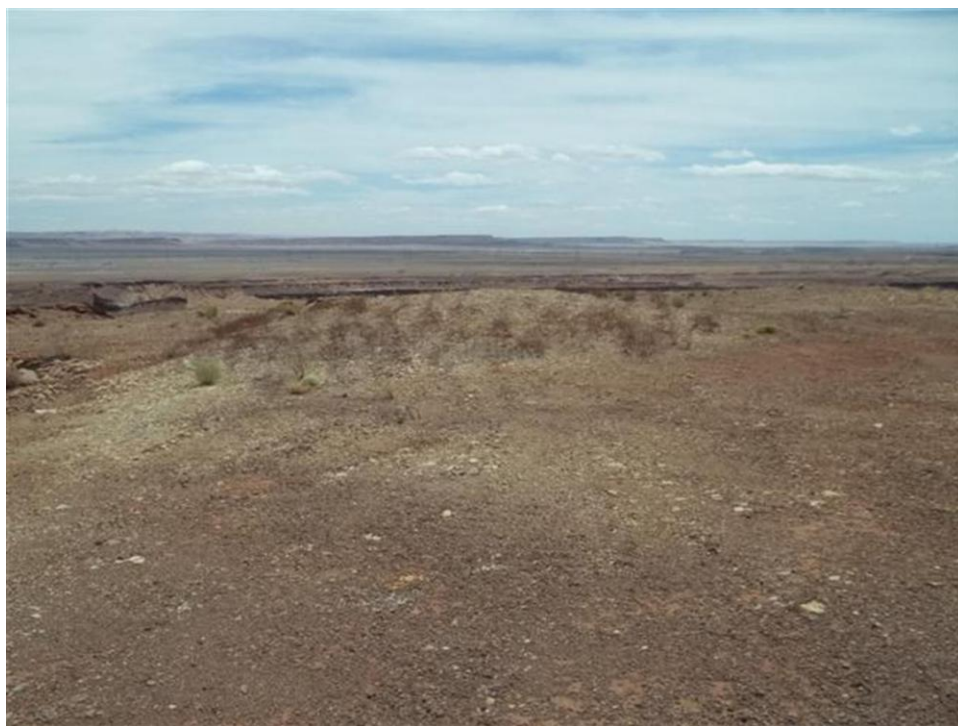
Reclamation cap, 70'x40'x5', light brown small rock fragments

Photo 4: Mine Site #165; Reclamation area

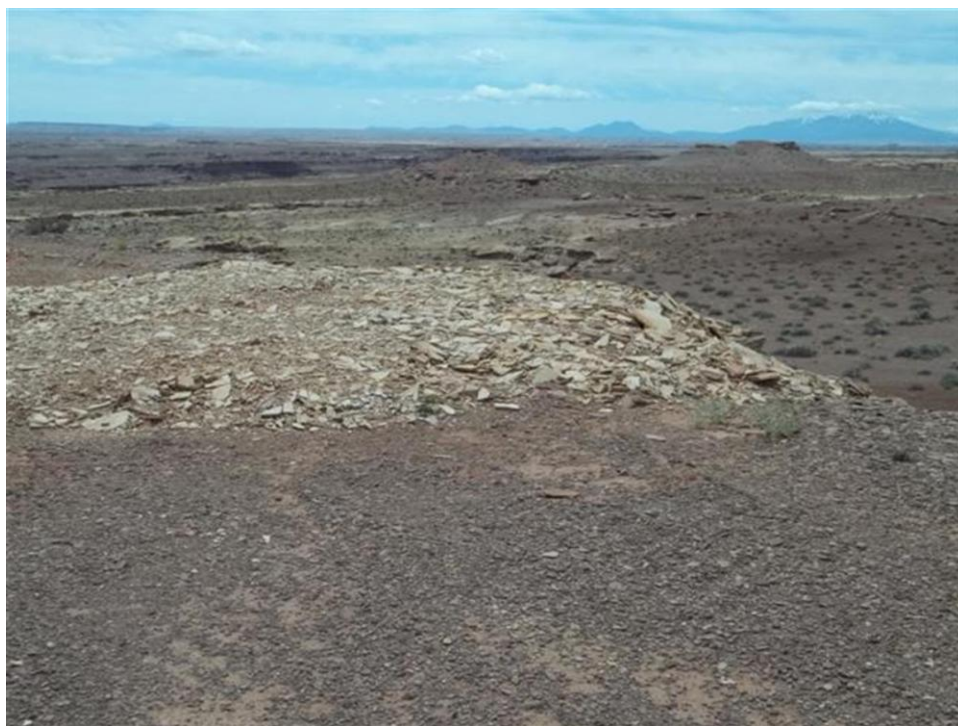
2 waste rock piles: Pile 1 - 15'dia x 1.5'h, light brown rock fragments; Pile 2 - 40' x 30' x 1', near ledge

Photo 5: Mine Site #165; Waste rock

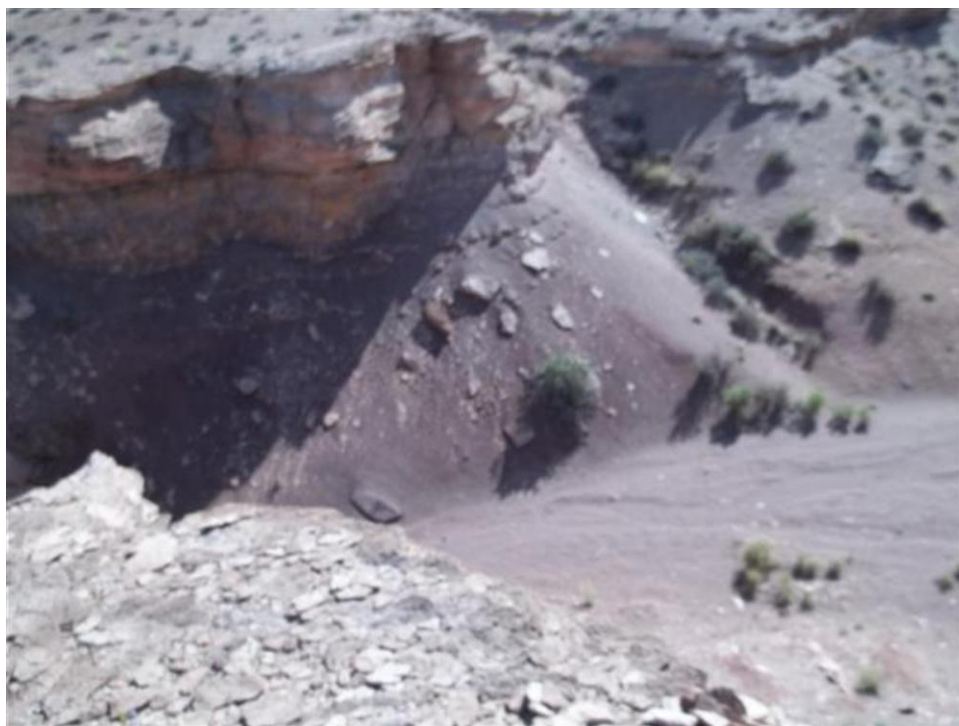
Photo 7: Mine Site #166; Drainage

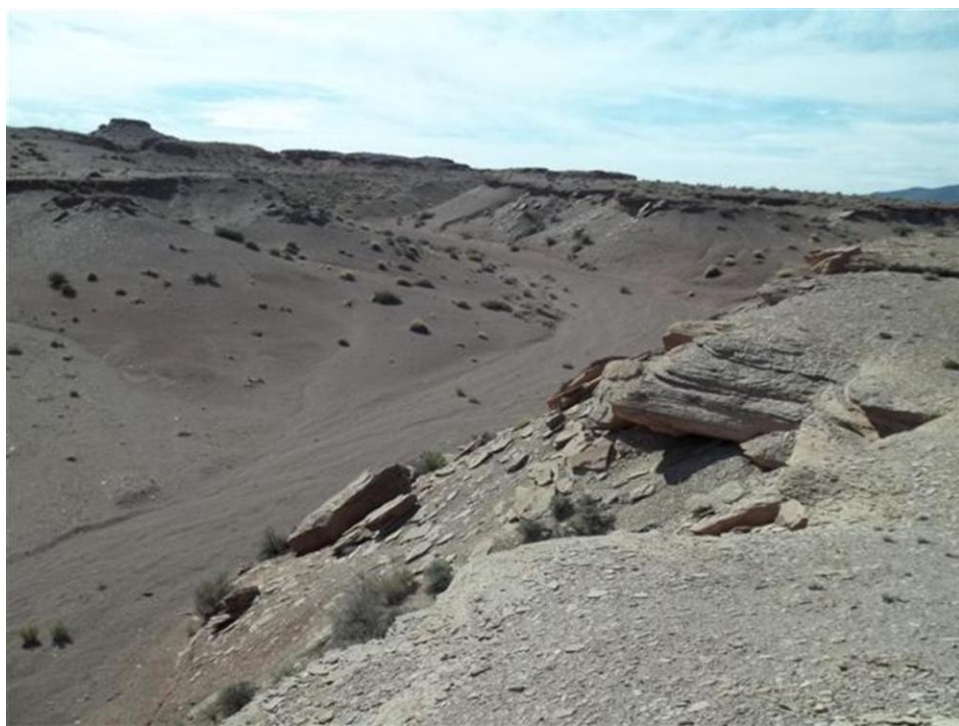
Photo 8: Mine Site #166; Drainage

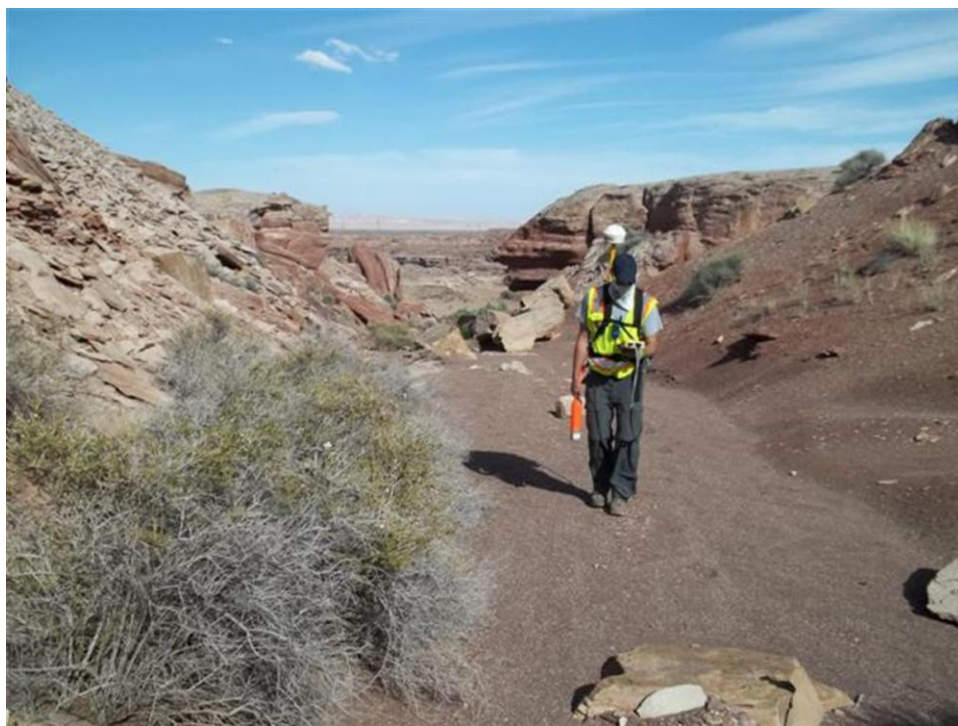
Photo 9: Mine Site #166; Drainage

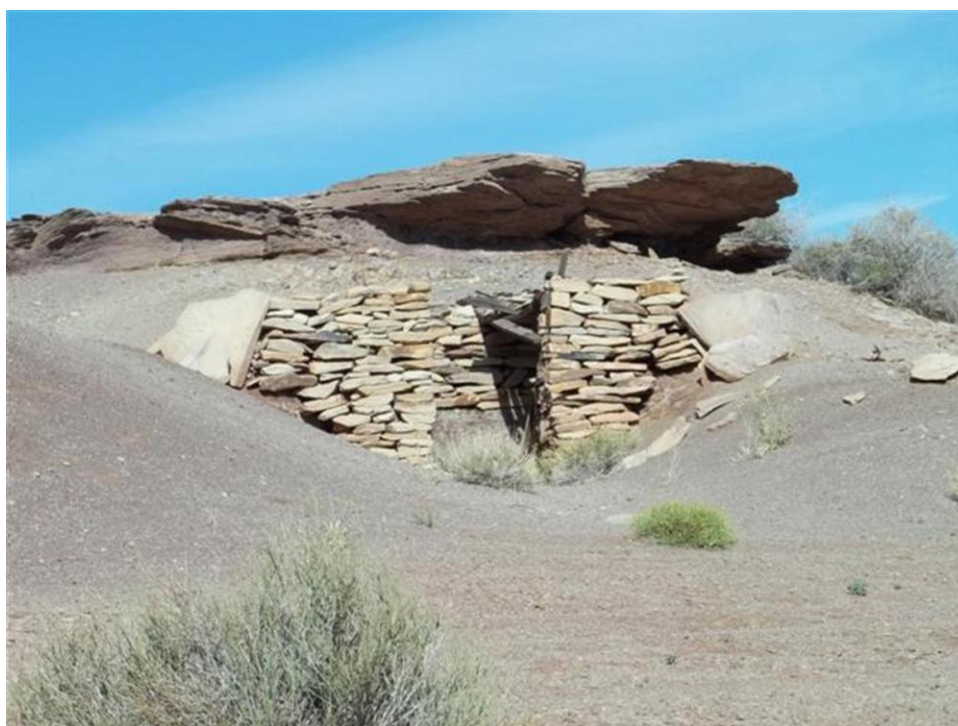
0 to 200 feet: No residential structures were observed, but a collapsed stone Hogan was located on site #66

Photo 10: Mine Site #166; Hogan in southwest part of site
